Manhole Inspection Summary

Manhole # S25AA1018MH

Insp Date: **1/29/07 9:34 AM**

Location Address: **1214 36TH ST**

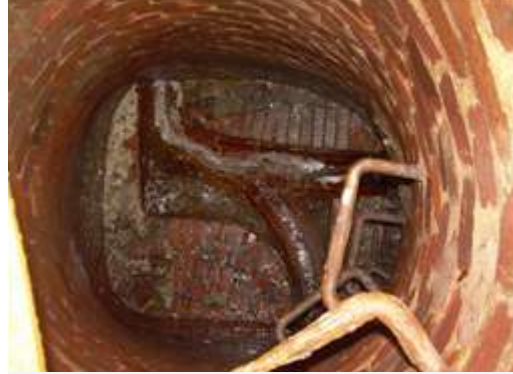
Top View

Corroded steps. Bench debris.

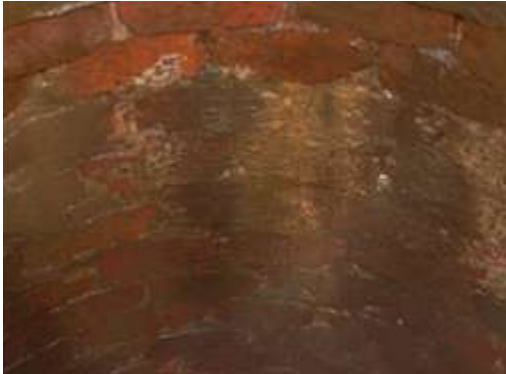
Defect

Frame leaks. Adjustment and Corbel infiltration.

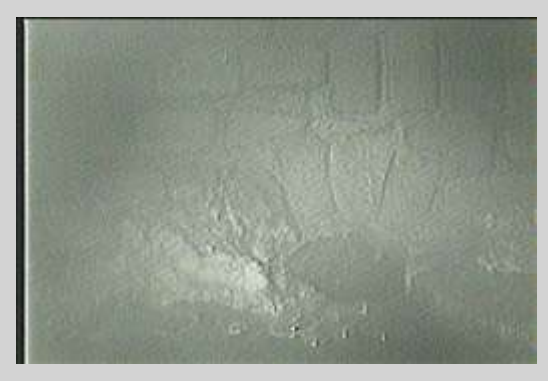
8 in. Circular Gravity Sewer Pipe Out @ 12 O'Clock

Deposits: ☐ None ☒ **Mud** ☐ Sludge ☒ **Debris** ☐ Grease

Silt Depth: **2** (in.) Deposits Extent: **Light**

Infiltration: **Evidence** Pipe Seal Cond: **Roots**

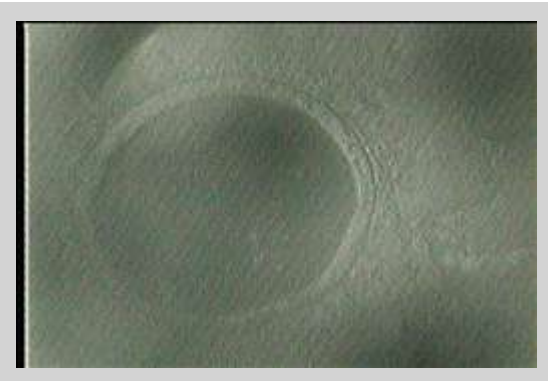
8 in. Circular Gravity Sewer Pipe In @ 4 O'Clock

Deposits: ☐ None ☒ **Mud** ☐ Sludge ☒ **Debris** ☒ **Grease**

Silt Depth: **3** (in.) Deposits Extent: **Medium**

Infiltration: **Evidence** Pipe Seal Cond: **Cracked**

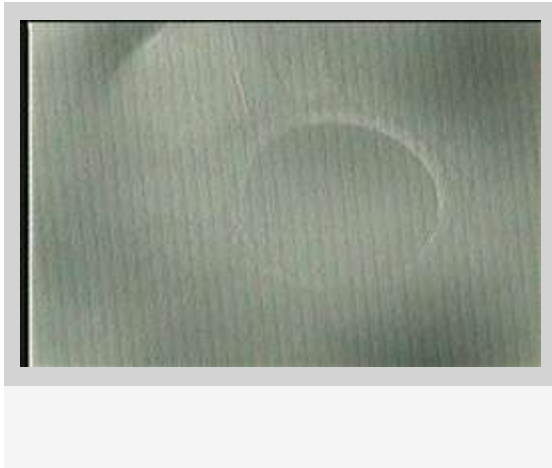
Pipe In @ 6 O'Clock

Pipe Seal Cond: **Cracked**
